PRKI-Service

Philips Radio Kommunikations Industri A/S (Copenhagen)

Concerning:	AP 4000 Serie Handset	93.01
--------------------	------------------------------	--------------

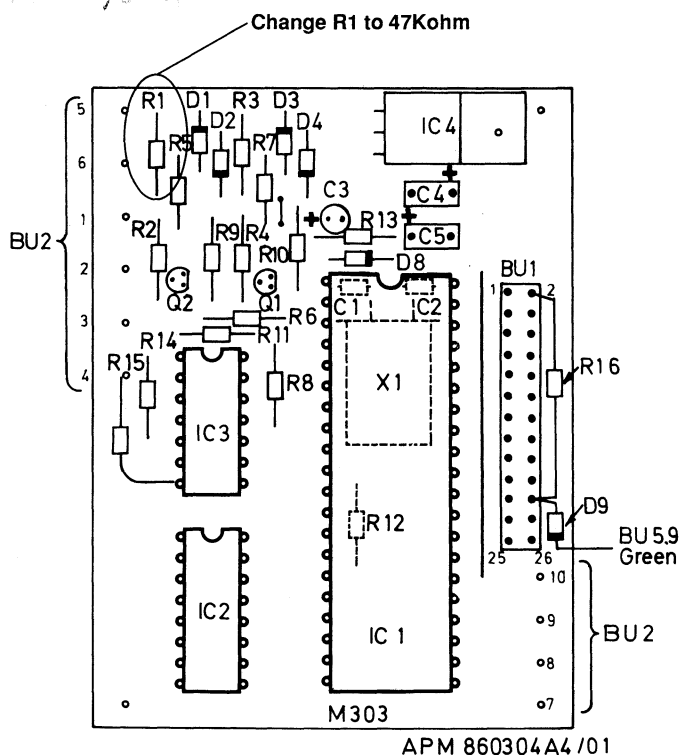
Component location AP4009

To improve the communication between service interface unit AP4009 (SIU) and connected radio telephones, you may change the resistor R1 in the SIU to 47Kohm (See drawings below).

Ordering number for resistor R1, 47Kohm: 4822 116 52472.

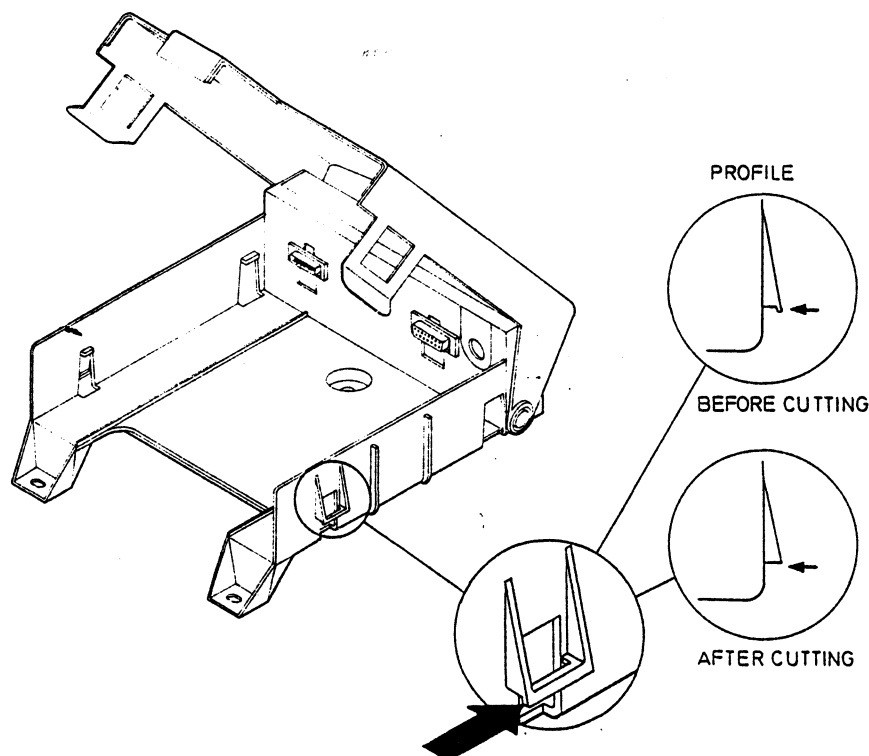
If the mounting cassette is mounted upside down e.g. under the dashboard it will be convenient to make a small modification on the cassette before it is mounted.

On the locking part of the cassette (both sides) is a small retaining rim at the edge (see detail on drawing below). Use a sharp instrument to remove these rims in order to avoid breaking the locking flaps on the lid when opening the cassette after the telephone has been installed.

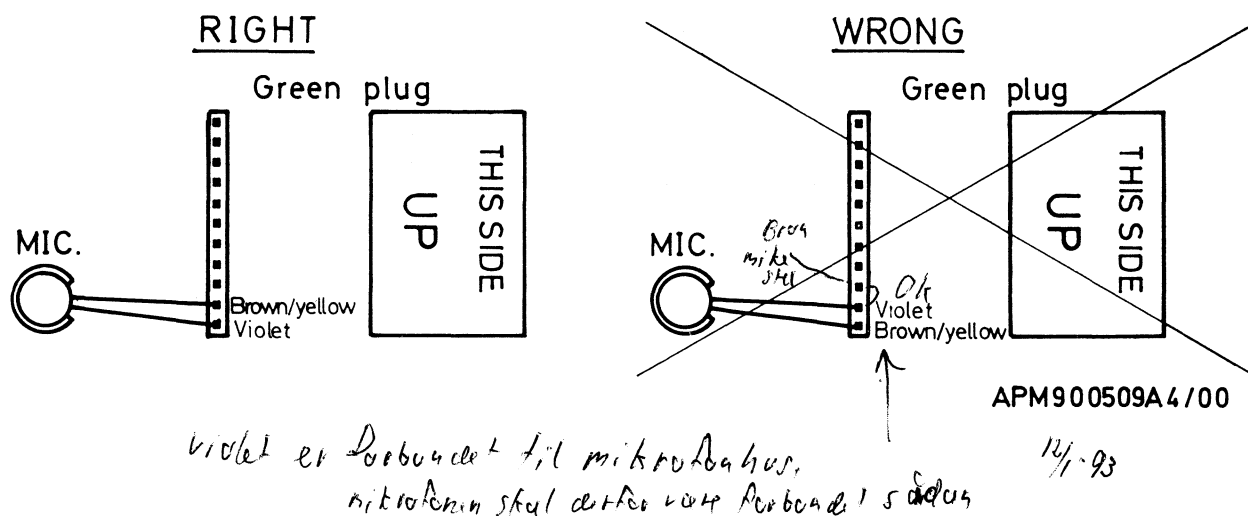
A-packages and B-packages which is delivered in the weeks 9013 to 9018 (both included) might have a handset, AP4007, with reduced gain in handset microphone. The reason is a wrong placement of the two wires from the microphone, into the green plug. To get the right gain in the microphone, please change the placement of the two wires (see drawings below).

To get the socket out of the plug, press carefully the spring on the socket when pulling the wire, with the socket, out of the plug.

When mounting the wires, press the sockets into the green plug (remember to place the spring on the socket, the right way in the green plug).

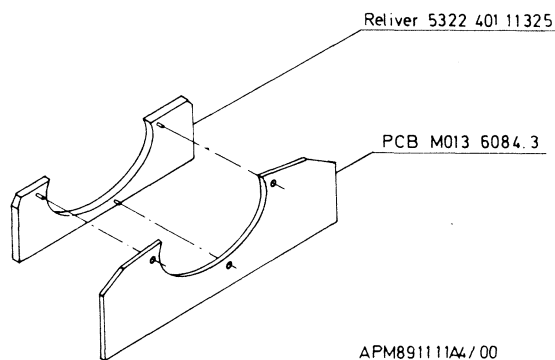
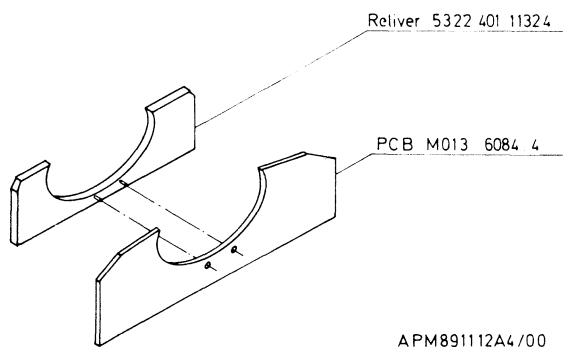
To avoid disconnection of wires on the PCB M013, please do as follows:

Disconnect the wires and place the reliver on the PCB M013.

Keep the reliver close to the PCB and connect the wires to the PCB, by inserting the wires through the holes in the reliver and then connect/solder the wires to the PCB (see drawings below).

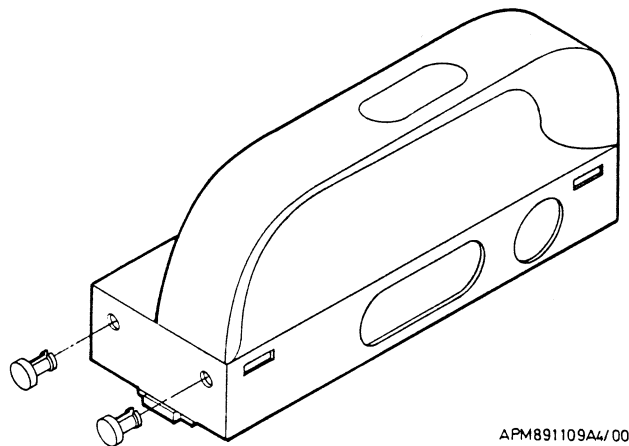
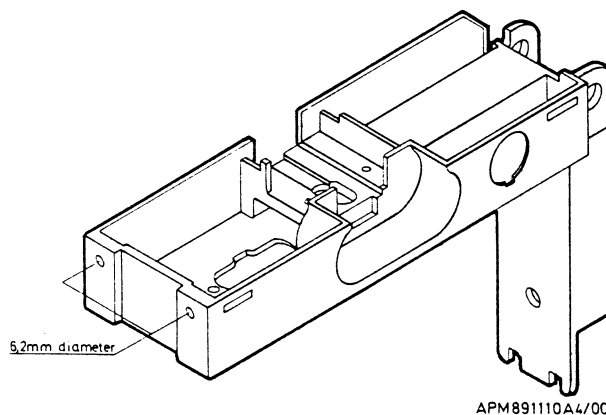
From ultimo october, the two screws 12NC 5322 502 21113 , and the two cap plugs 12NC 5322 462 41424 , will be replaced by two snaps 12NC 5322 417 50261.

When inserting the snaps, be sure that the slot is located vertically (see drawing below).

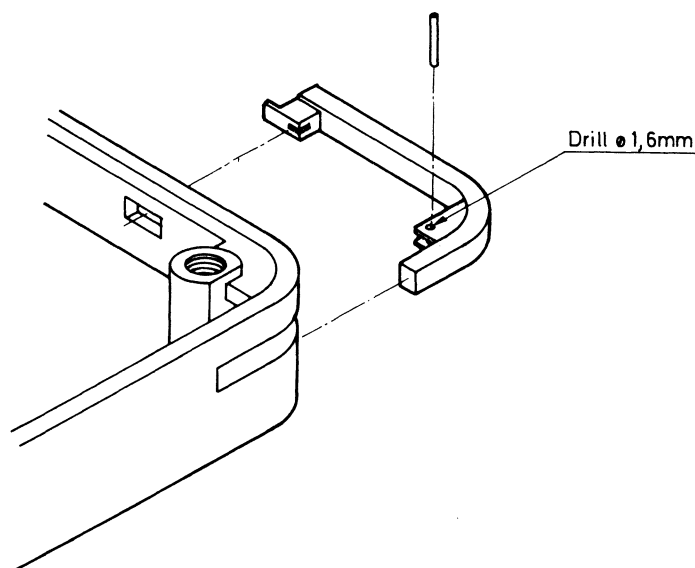
Ordering bottom part, 12 NC 5322 462 41465 , please notice that hole for fastening does not exist. That is quite normal !

The reason for that is tolerances. If the hole are made in advance, there can be some cases where the bottom part will come loose after mounting on the frontpart.

1. Put the bottom part on the battery.
2. Make a mark on the bottom part as close as possible to the frontpart, inside.
3. Take away the bottom part and make a hole by drilling, diameter 1.6mm, where the mark have been maked.
4. Put the bottom part on the battery and fasten the bottom part with the clamp pin.

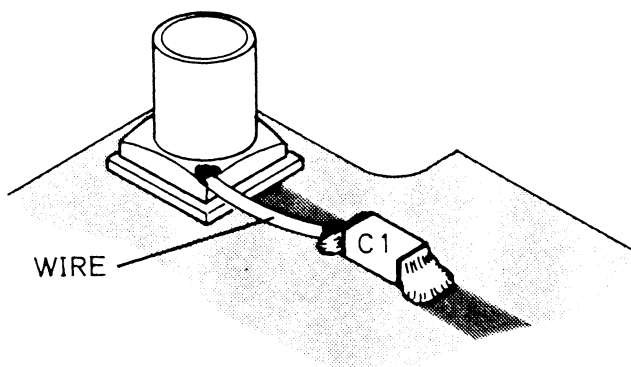
When changing the PA-module or the power amplifier pay close attention to the following.

At the MCX plug where the signal from the TX-module enters add 8mm of 0.3square mm tinned wire between the base of the MCX plug and C1 (see figure below).

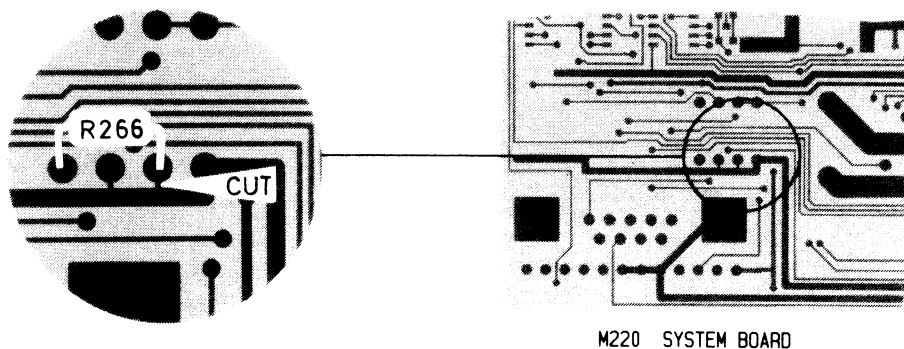
Fig 1.

Lately two new types of EEPROM has been introduced on the systemboard, one marked CAT93C46PI or one marked CAT93C46API. Unfortunately the one marked CAT93C46PI will not work unless the following modification has been made on the systemboard:

Cut the print connection between IC218 pin 6 and ground, and add a resistor R266 between IC 218 pin 6 and pin 8.(See fig 1.)

R266 10 Ω 1/10W Ordering number 2322 180 73109

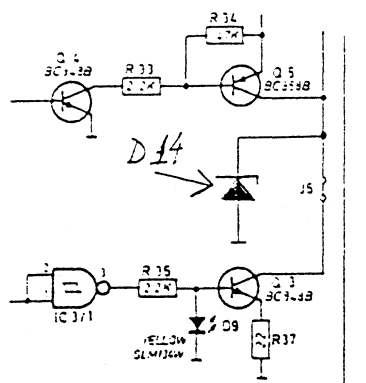
Figure 1.

Problem : Q3 and Q5 on unit 1, the systemboard (M120 or M220) are defective due to inductive spikes from the relay RE1.

The diode might be added as a preventive action when the telephone is handed in for service.

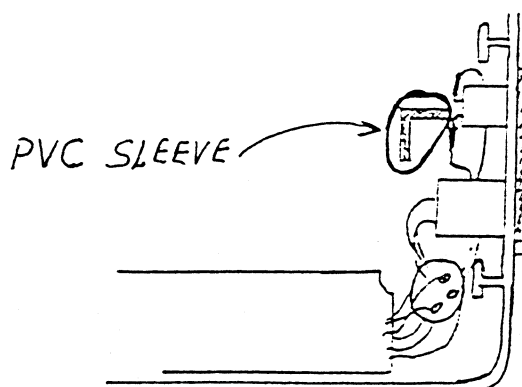
Figure 1.

1. In battery packs produced before June 1988 a shortcircuit might occur between battery indicator LED D9 and ground. This shortcircuit will only cause damage when the battery is supplied from e.g. the car battery via the DC cigar lighter cable.

Cut a piece of PVC sleeve 2.5 centimeters, ordering number 0822 026 22235 (sold in meters), and slide the sleeve piece over the L-shaped terminal as shown on figure 1.

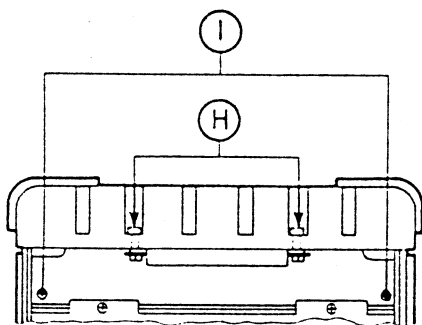
Figure 1.

Fieldtest have shown that the PA-module and the Duplex-filter might come loose as time passes.

We therefore strongly recommend that, when a telephone is handed in for service, the screws holding both modules in question are tightened.

For AP 4xxx see items H, I, J, on figures below.

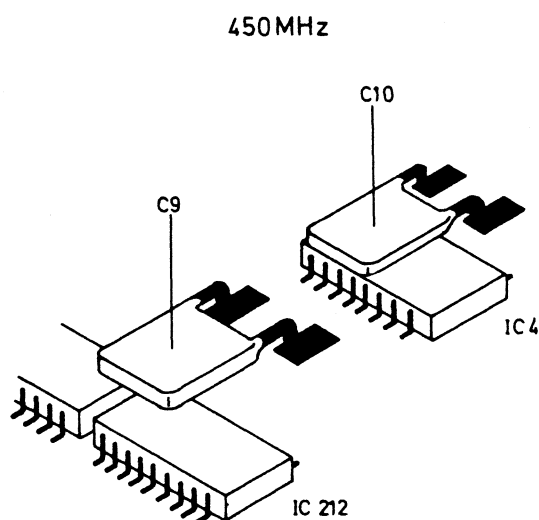
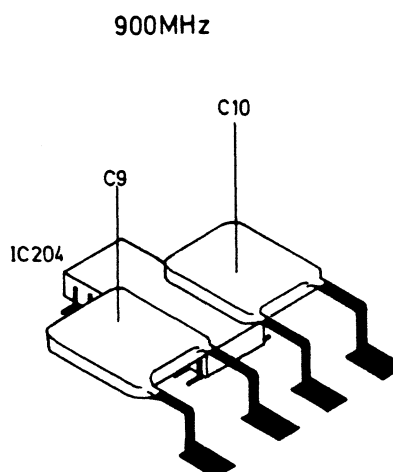
Fault : The mobile telephone switches itself off or may fail in the start-up procedure.

Troubleshooting: The capacitors C9 and C10 on the system board, unit 1, fails.

Repair : Remove the two SMD capacitors.

Mount two new capacitors of the type 3508 100 31250 (270N) as shown on the figure.

Alternatively it is possible to use type 3508 100 31240 (220N) or type 3508 100 31260 (330N), but the two capacitors (C9/C10) must always be of equal value.

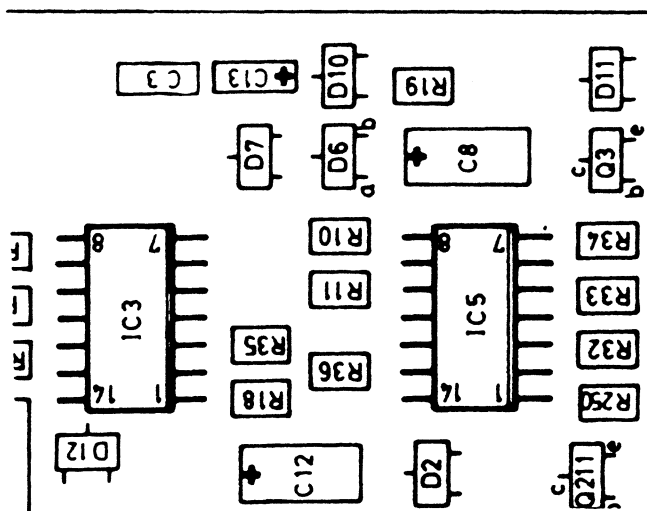
Troubleshooting: A diode D10 is mounted across R19 in some earlier production series. This causes to high voltage on the capacitor C13.

Repair : Remove D10 (and shift C13).

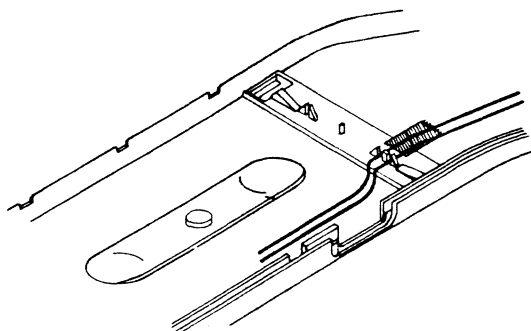
Troubleshooting: The wires for the handset loudspeaker may have been squeezed with a shortcircuiting between the shielded underpart and the loudspeaker wire as a result.

Repair : Shift the wires for the loudspeaker and place a small piece of isolating tape on the bottom part of the handset as shown on the figure.

NOTE: The introduction of the above shown change is recommended to be made in all handsets handed in for repair at the service shop. The change has been introduced in the factory from handset No. 25601.
