Date / Datum / Date / Fecha / Dato December 1979

CONC. REMOTE CONTROL H1200

S. P. RADIC

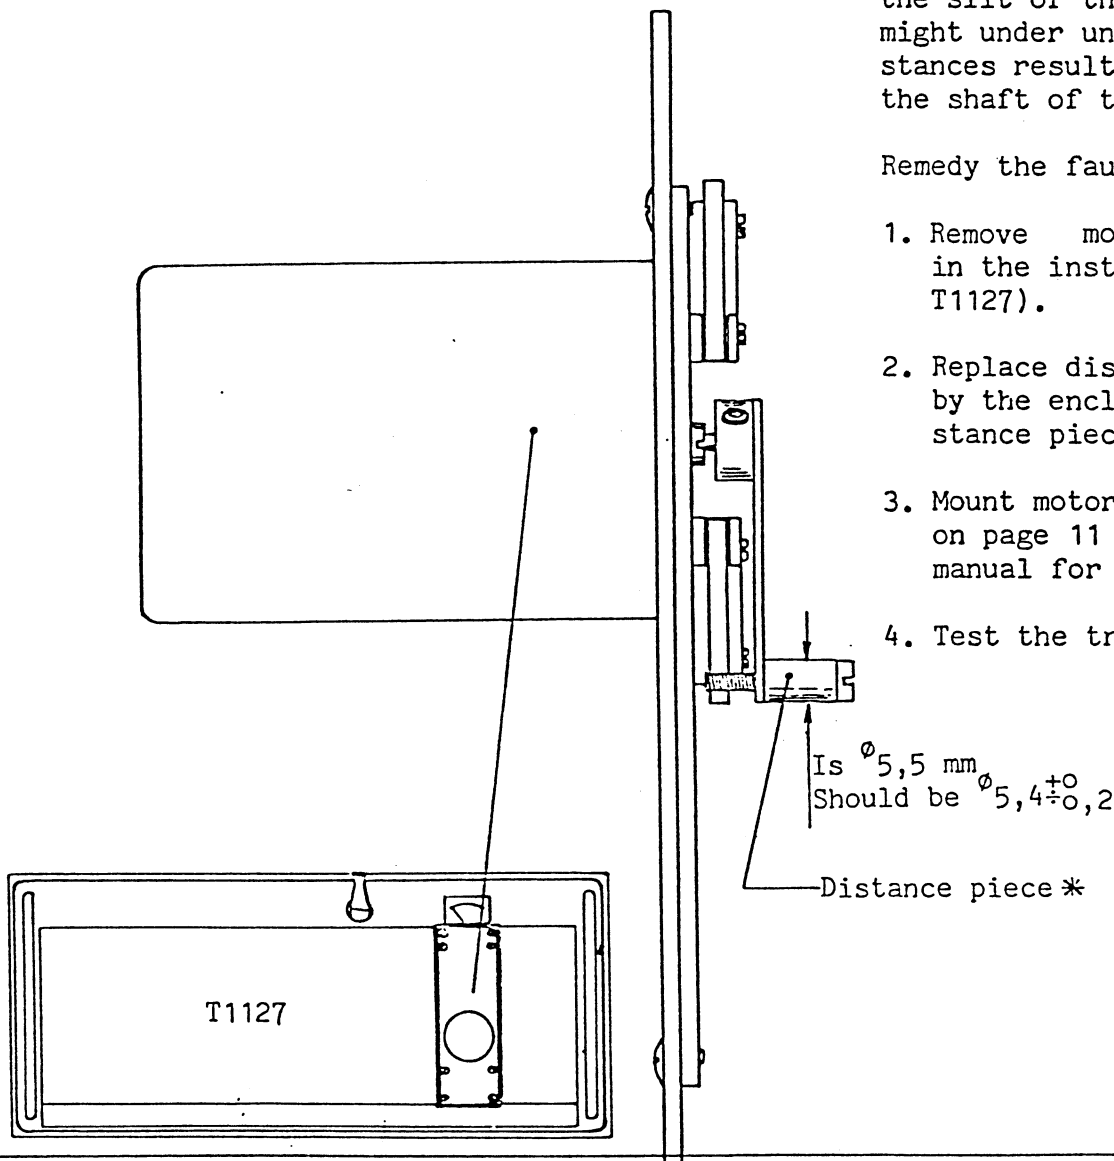
The fault is that the distance piece marked * on the drawing has been manufactured with an outside diameter of 5.5 mm instead of $\phi 5.4^{+0}_{-0.2}$ mm, which is correct.

The effect is that the distance piece is working very tightly in the slit of the TUNE shaft, which might under unfortunate circumstances result in an overload of the shaft of the motor.

Remedy the fault as follows:

1. Remove motor (see page 11 in the instruction manual for T1127).
2. Replace distance piece marked * by the enclosed correct distance piece.
3. Mount motor unit as described on page 11 in the instruction manual for T1127.
4. Test the transmitter.
