PRKI-Service

Philips Radio Kommunikations Industri A/S (Copenhagen)

Concerning:	AP 4000 Serie Handset	93.01
--------------------	------------------------------	--------------

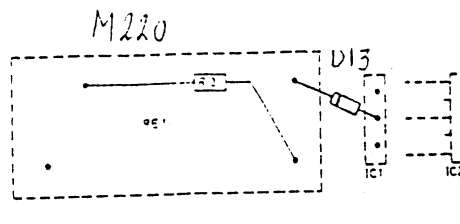
Figure 2.

Problem : Q3 and Q5 on unit 1, the systemboard (M120 or M220) are defective due to inductive spikes from the relay RE1.

For M220 refer to figure 2.

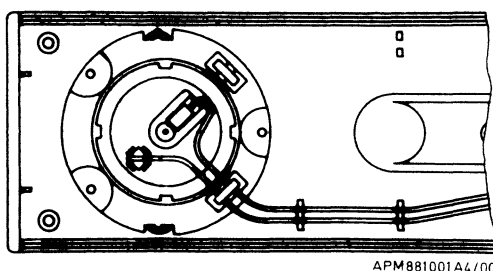
Fig. 1 Handset horizontal right, vertical

IMPORTANT: Fig. 1 and fig. 2 show how to place the earpiece loudspeaker connections.

Ordering number is 8208 244 00281 for horizontal handsets (right) and vertical handsets.

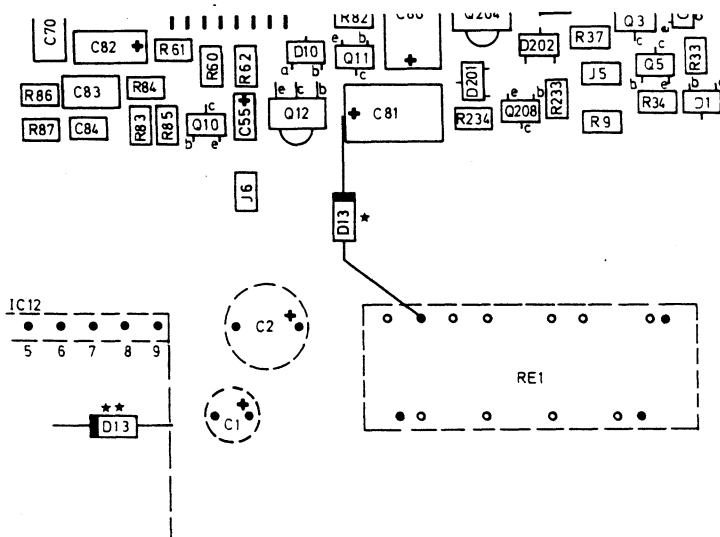
D13* Is mounted in system boards marked 3508 101 6124.1 (can also be mounted in earlier versions).

D13** Is mounted in system boards marked 3508 101 6124.2.
